POLYTECHNIC OF NAMIBIA

Department of Civil Engineering

**Site Investigation Report: Orban Primary School Storm
Water Drainage Project**

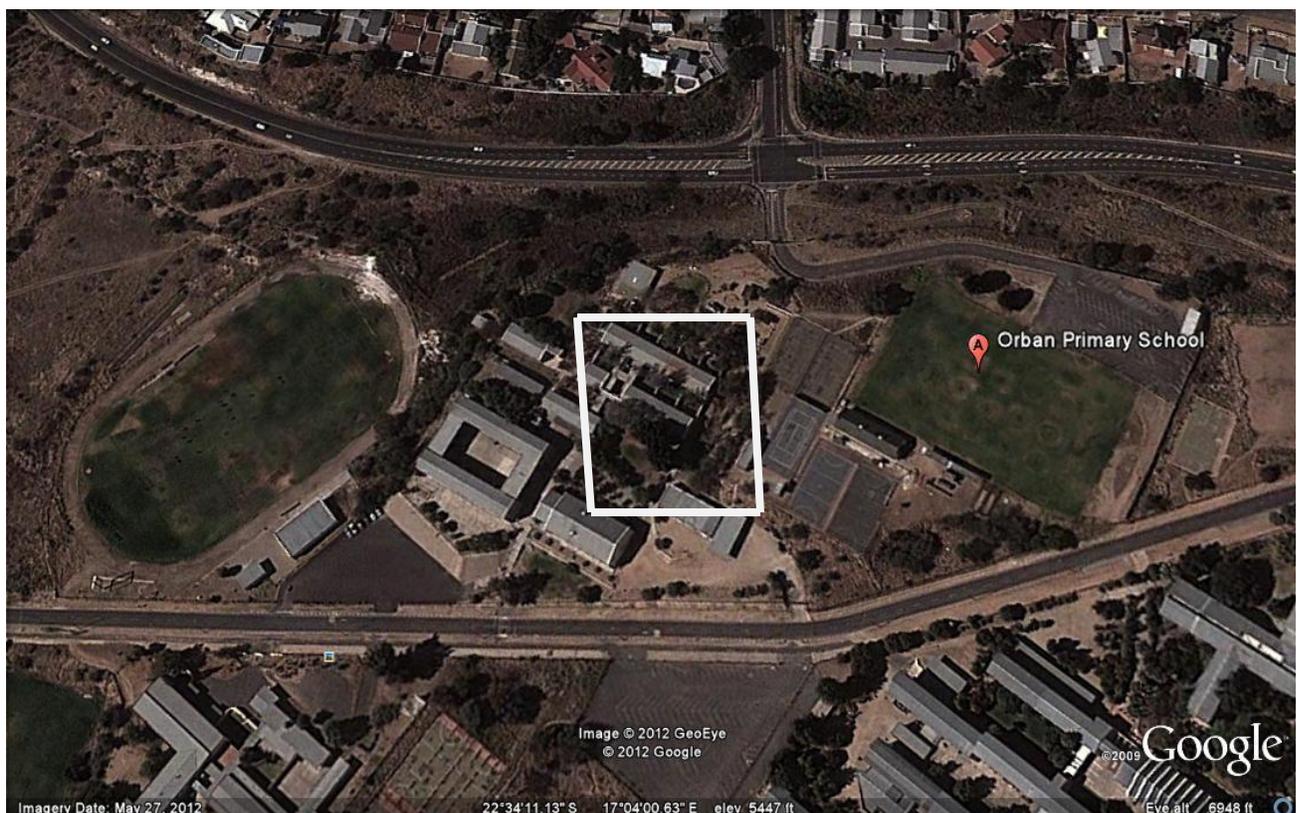
During the rainy season, storm water accumulates on the on the western side of one of the classroom's block from the runoff from hill nearby. This water does not drain because it does not seep underground due to the bedrock that is closer to the surface and there is no channel to divert water to the riverbed on the eastern side.

Fig.1: Aerial photograph of the site (critical area is highlighted)

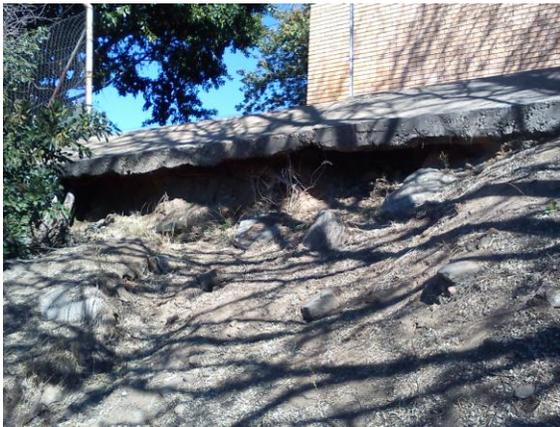
The existing buildings are not currently affected but are observed to be scoured. The existing canal that is diverting water from the gutters of the blocks is no longer effective because the slope is against the flow of storm water as the roots of the trees nearby have uplifted the canal. Soil erosion is another serious problem that is affecting some existing structures.

Fig.2: Scouring

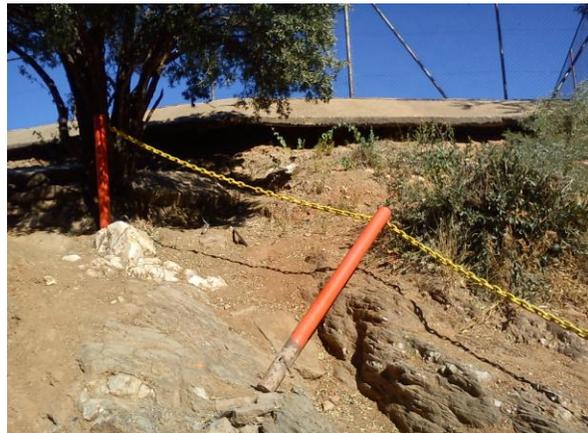
Fig.3: Scouring and erosion

The solution to the problem of erosion is still to be thought of upon the agreement with the client (school) in terms of funding otherwise the focus can only be put on the problem of water logging on the pathway to the sport fields.

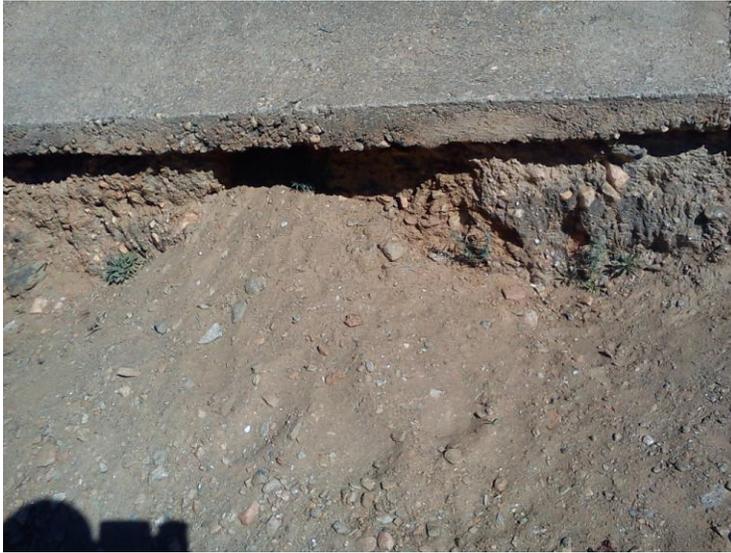
The school is not only facing the water logging problem, but soil erosion and ground squirrels on most of the structures is another serious problem that has to be addressed. From the site investigation conducted the following solution is suggested. The existing canal will be redesigned because it is observed to be sloping against the flow of water to the riverbed due to the uplift by roots of the nearby trees. The northern part of this site will be filled up and well compacted with G5 (natural gravel) material, paved with interlocks and leveled to ensure that water flows to the new canal.

Fig.3: Effects of ground squirrels
